Product Title

Stepper driver motor with flying wires Part Number 551-02933-jvt

A New improvement to the reliability of the Mattson Aspen II system.

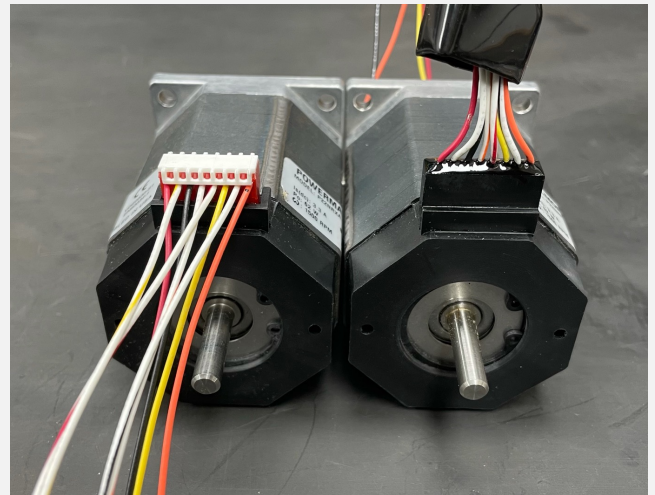
The original stepper driver motor for the robot lift movement has a plug and crimped wire connection. Over time this plug has become loose or a wire connection has become wobbly. Some tools has shown signs of an overheated crimp connection and even a melted plastic plug.

To improve this design a factory made up-grade motor with flying leads has been created. This welded joint not only improves the connection of the wires to the motor, it also improves the stability of the mechanical movement of the wires.

Guaranteed quality: The new motor is from the original manufacturer, ensuring that it meets the same high standards as the original motor and is reliable and allows for a plug and play installation.
